**Flood Control Project Maintenance  
Levee Inspections**

**Maintenance Issue Types Only, Levee Inspection Report By Mile - Fall 2015**

**Sutter Maintenance Yard Hamilton Bend**

Waterway	Bank	Unit Miles	Inspection Start/End	Inspector
Unit No. 01 Feather River Hamilton Bend	Right	3.39	11/16/2015 11/16/2015	Bob Duffey

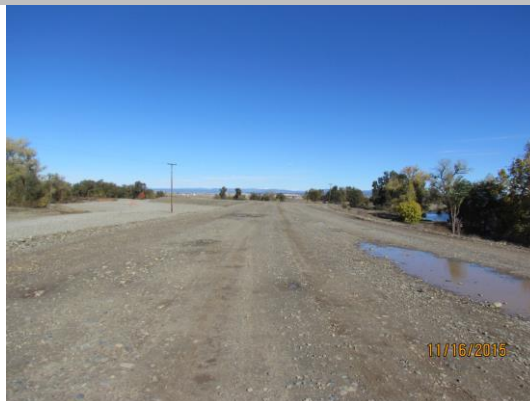
Photo 1 of 1 : FA\_2015\_ST0005\_289\_13\_20151118\_00013.jpg

LM Start	0.00	Rating **	A	Issue No.	13
LM End	1.21	Issue Type +	Ma	Location *	CR
Category	Earthen Levee			GPS Latitude/Longitude	
				Start	End
Item	Crown Surface / Depressions / Rutting			39.439712 °	39.456765 °
				-121.641457 °	-121.639258 °
DWR ID	DWR_ST0005_01_f_2015_13				
Action/Comments					
Add appropriate material and re-grade the levee to bring the crown above the design elevation.					
Inspector Comments: The SBFCA levee project is still in construction phase so I was unable to inspect the levee from levee mile 0.00 to 1.21.

View of the crown roadway under construction.

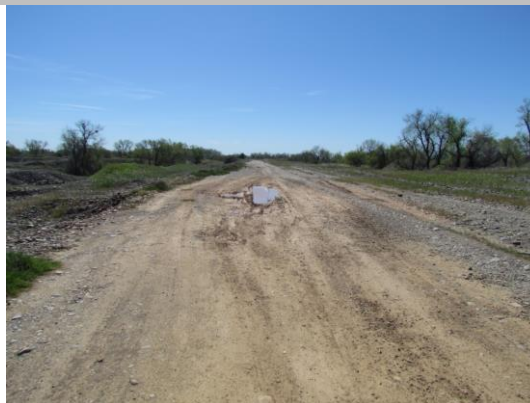
Photo 1 of 1 : FA\_2015\_ST0005\_289\_12\_20151109\_00004.jpg

This photo was taken from the levee crown facing north looking at crown surface depressions caused by vehicle traffic. Spring 2014.

LM Start	0.37	Rating **	M	Issue No.	12
LM End	0.37	Issue Type +	Ma	Location *	CR
Category	Earthen Levee			GPS Latitude/Longitude	
				Start	End
Item	Crown Surface / Depressions / Rutting			39.445008 °	39.445008 °
				-121.641811 °	-121.641812 °
DWR ID	DWR_ST0005_01_s_2014_12				
Action/Comments					
Repair depressions or ruts in the crown or slope.

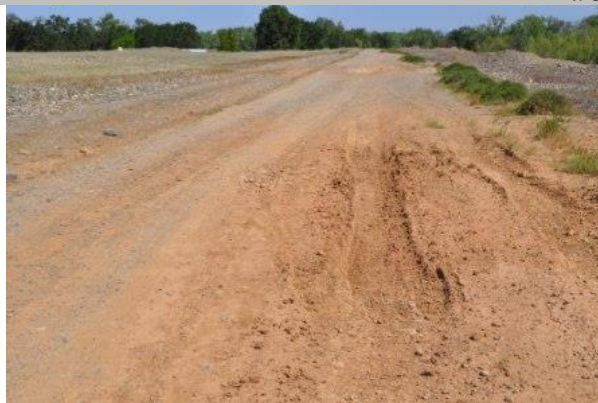
Photo 1 of 1 : FA\_2015\_ST0005\_289\_2\_20151109\_00001.jpg

Deep rut in crown. Repair prior to flood season.

LM Start	0.40	Rating **	M	Issue No.	2
LM End	0.40	Issue Type +	Ma	Location *	CR
Category	Earthen Levee			GPS Latitude/Longitude	
				Start	End
Item	Crown Surface / Depressions / Rutting			39.445420 °	39.445430 °
				-121.641809 °	-121.641802 °
DWR ID	DWR_ST0005_01_s _ 2015_2				
Action/Comments					
Add appropriate material and re-grade the levee to bring the crown above the design elevation.

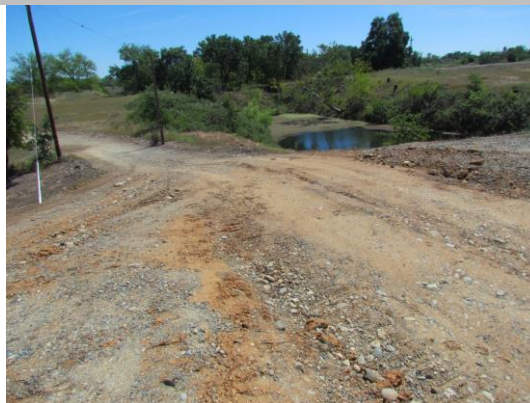
Photo 1 of 2 : FA\_2015\_ST0005\_289\_18\_20151109\_00005.jpg

View of the depression on the crown facing the waterside of the levee.

LM Start	1.08	Rating **	U	Issue No.	18
LM End	1.08	Issue Type +	Ma	Location *	CR
Category	Earthen Levee			GPS Latitude/Longitude	
				Start	End
Item	Crown Surface / Depressions / Rutting			39.454935 °	39.454935 °
				-121.640097 °	-121.640097 °
DWR ID	DWR_ST0005_01_s _ 2015_18				
Action/Comments					
Repair depressions or ruts in the crown or slope.

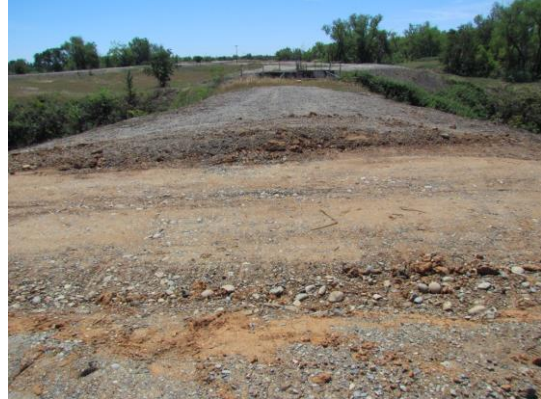
Photo 2 of 2 : FA\_2015\_ST0005\_289\_18\_20151109\_00006.jpg

View of the depression on the crown facing downstream.

LM Start	1.08	Rating **	U	Issue No.	18 (cont)
LM End	1.08	Issue Type +	Ma	Location *	CR
Category	Earthen Levee			GPS Latitude/Longitude	
				Start	End
Item	Crown Surface / Depressions / Rutting			39.454935 °	39.454935 °
				-121.640097 °	-121.640097 °
DWR ID	DWR_ST0005_01_s _ 2015_18				
Action/Comments					
Repair depressions or ruts in the crown or slope.

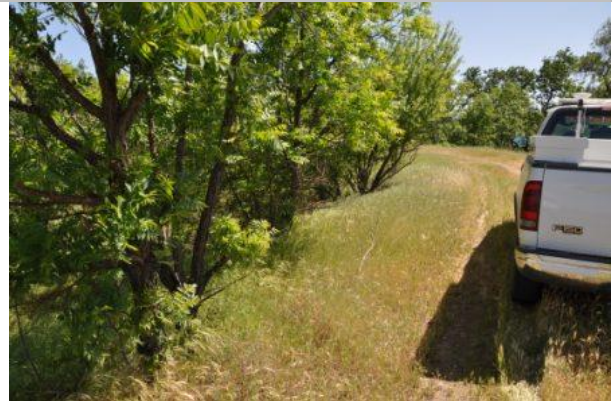
Photo 1 of 1 : FA\_2015\_ST0005\_289\_4\_20151109\_00002.jpg

L/S trees.

LM Start	1.48	Rating **	M	Issue No.	4
LM End	3.26	Issue Type +	Ma	Location *	LS
Category	Earthen Levee			GPS Latitude/Longitude	
				Start	End
Item	Trim / Thin Trees			39.458060 °	39.470433 °
				-121.636332 °	-121.609200 °
DWR ID	DWR_ST0005_01_s _ 2013_4				
Action/Comments					
Trim and thin trees to allow visibility of the ground and room to flood fight.

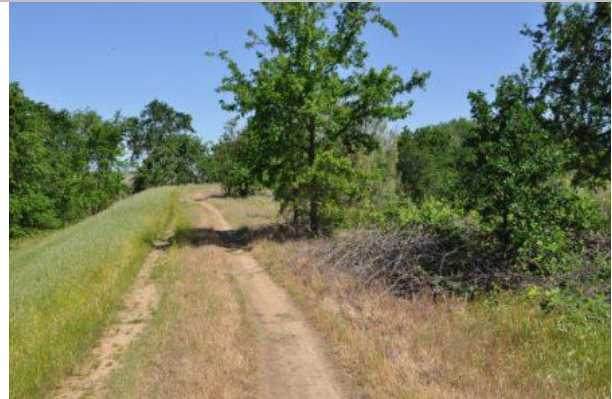
Photo 1 of 1 : FA\_2015\_ST0005\_289\_5\_20151109\_00003.jpg

W/S trees.

LM Start	1.51	Rating **	M	Issue No.	5
LM End	1.69	Issue Type +	Ma	Location *	WS
Category	Earthen Levee			GPS Latitude/Longitude	
				Start	End
Item	Trim / Thin Trees			39.458255 °	39.459451 °
				-121.635808 °	-121.633670 °
DWR ID	DWR_ST0005_01_s _ 2013_5				
Action/Comments					
Trim and thin trees to allow visibility of the ground and room to flood fight.
